INDIANA DAM SAFETY INSPECTION MANUAL

UPDATED 2007

PART 3 DAM SAFETY INSPECTIONS

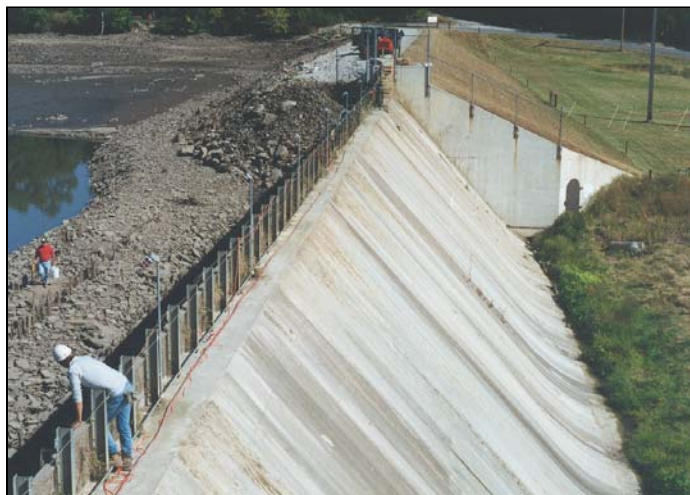
Figure 1-1 Knowledge of concrete and earth structures is required here.

Personnel that perform dam inspections must be knowledgeable in dam design, construction, and operation to effectively evaluate the dam conditions. The inspector should be an experienced, or trained, dam safety professional with expertise in the technical issues encountered at the dam. For instance, the inspector must have knowledge or expertise in structures if the dam has a significant concrete spillway structure, or knowledge or expertise in soils and geotechnical engineering if the dam has an earth embankment (see Figure 1-1). This

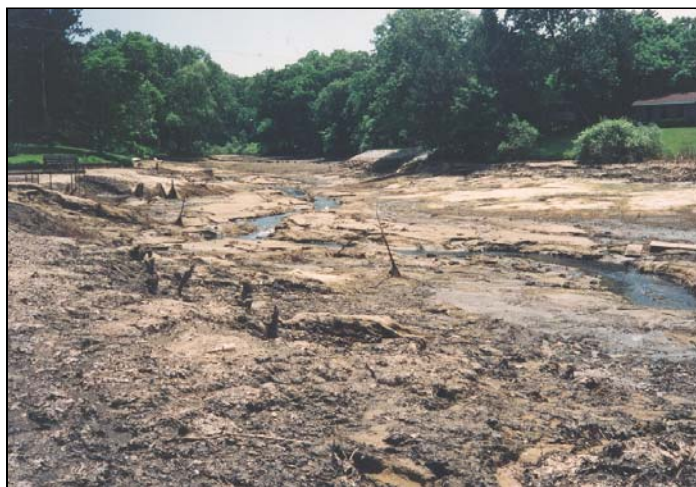
Figure 1-3 Dam breach failures cause significant downstream damage.

intended to provide a guide and reference to all individuals performing and reporting dam safety inspections. [Chapters 5 through 8](#) provide a quick reference to be used in assessing observed conditions, their probable cause and possible consequences, and remedial actions that may solve the observed problems or deficiencies. The dam owner or inspector can use the results of inspections to help identify any changes in previously noted conditions that may indicate a safety concern. Quick corrective action to conditions requiring attention will promote the safety and extend the useful life of the dam while possibly preventing costly future repairs (see Figure 1-3).

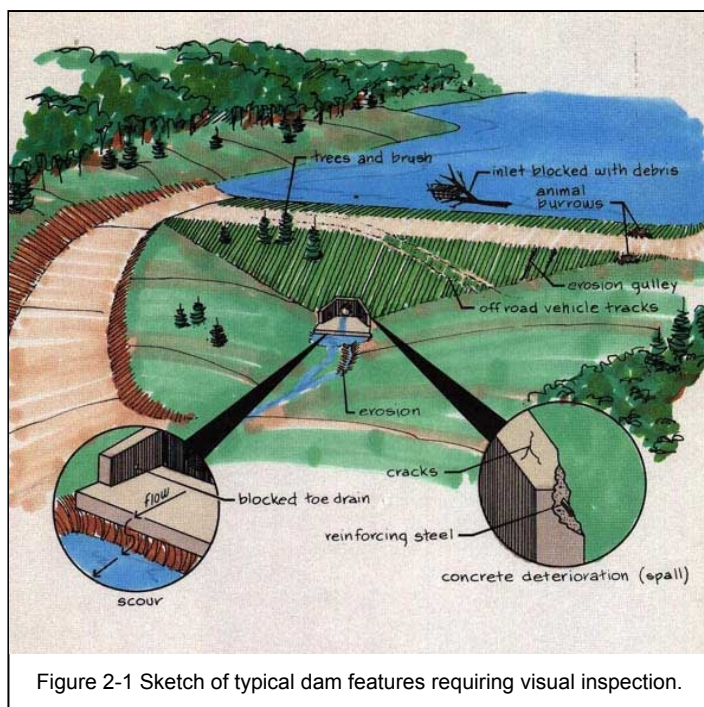
Figure 2-1 Sketch of typical dam features requiring visual inspection.

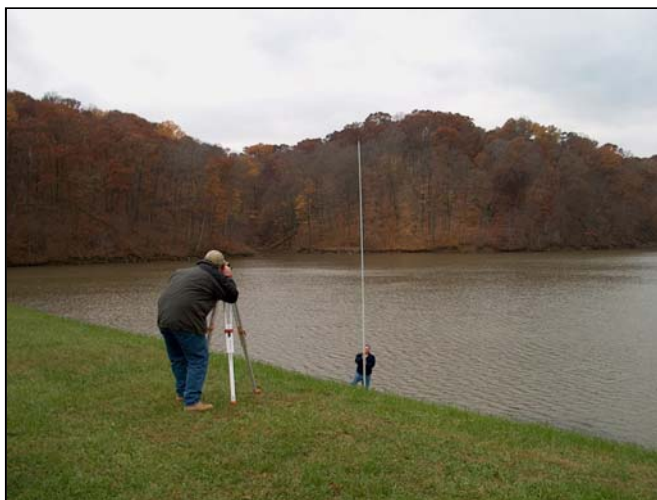
Figure 2-2 These inspectors are checking freeboard with a level and stadia rod.

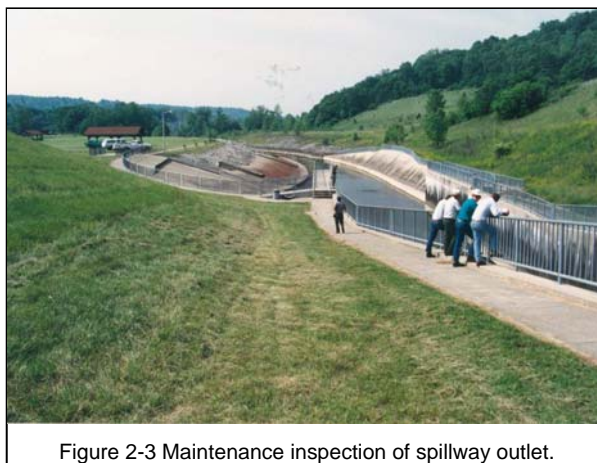
Figure 2-3 Maintenance inspection of spillway outlet.

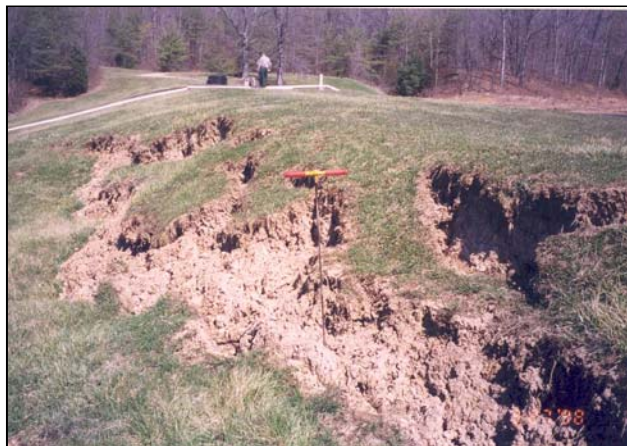
Figure 2-4 Photographic documentation of embankment slide.

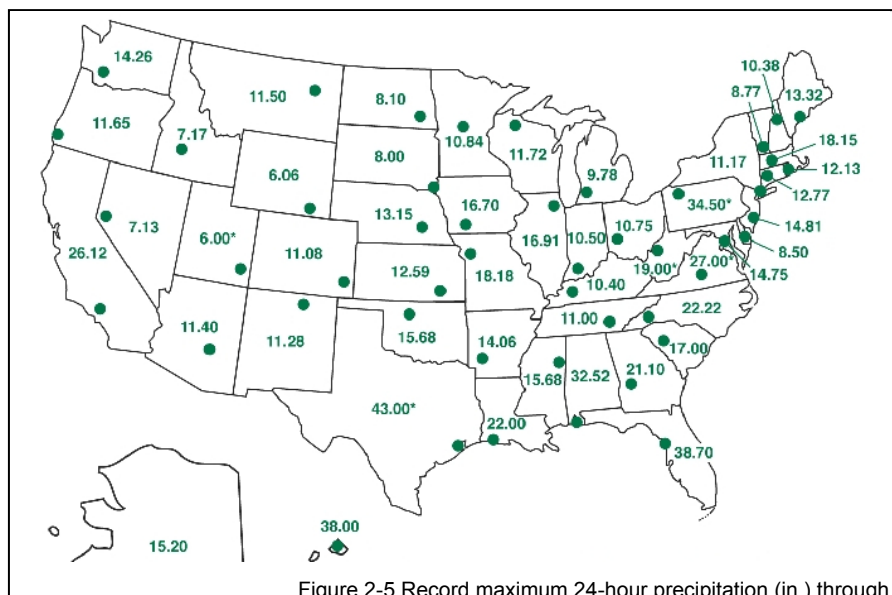
Figure 2-5 Record maximum 24-hour precipitation (in.) through 1998. Source: National Climatic Data Center/ National Oceanic and Atmospheric Administration (NOAA)

performance of their dam. Part 1 discusses geologic conditions that could impact dam operation. Figure 2-5 shows maximum recorded 24-hour precipitation events in the United States through 1988 (these values are not PMP values used in design). It shows actual rainfall events that have occurred, and provides an indication of the potential for extreme events. Figure 2-6 shows seismic contours in the Indiana area that represent horizontal acceleration from a seismic event with a 90% probability of not being exceeded in 250 years (typical design values). In general, areas that have acceleration values greater than 10 (i.e., horizontal acceleration values greater than 0.10 times the acceleration due to gravity) should always include a seismic stability analysis of the embankment.

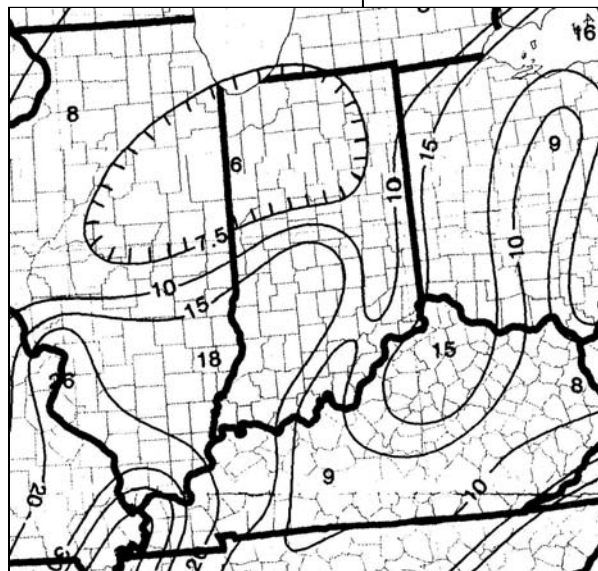
Figure 2-6 USGS seismic contour map, expressed as a percentage of gravity.

Source: Department of the Interior, U.S. Geological Survey

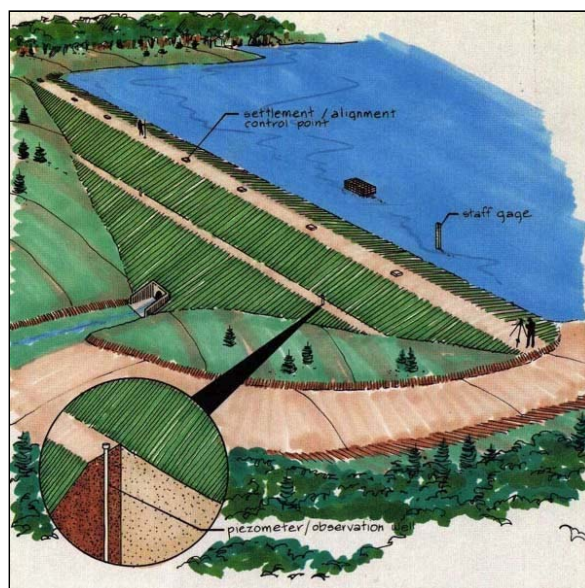
Figure 3-4 A dam sketch showing instrumentation points.

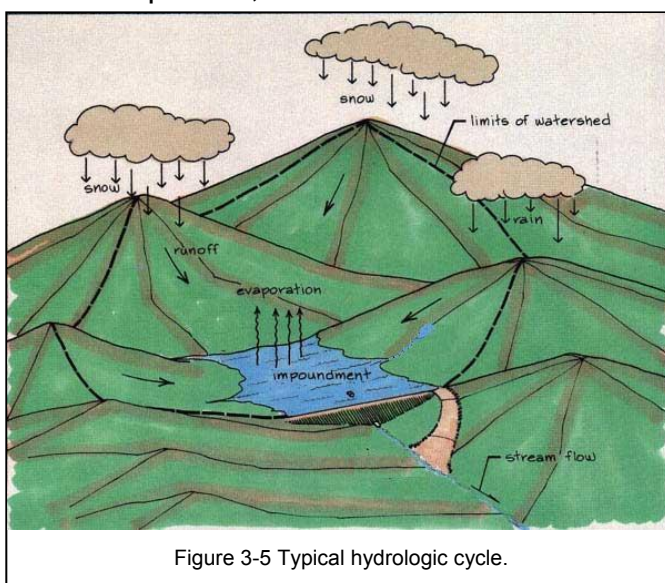
Figure 3-5 Typical hydrologic cycle.

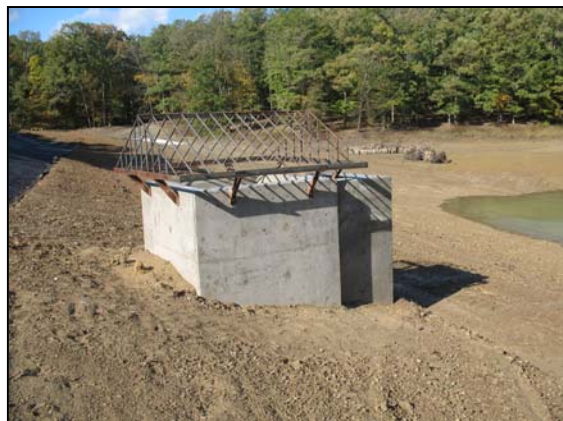
Figure 3-6 Construction photograph of spillway and embankment rehab.

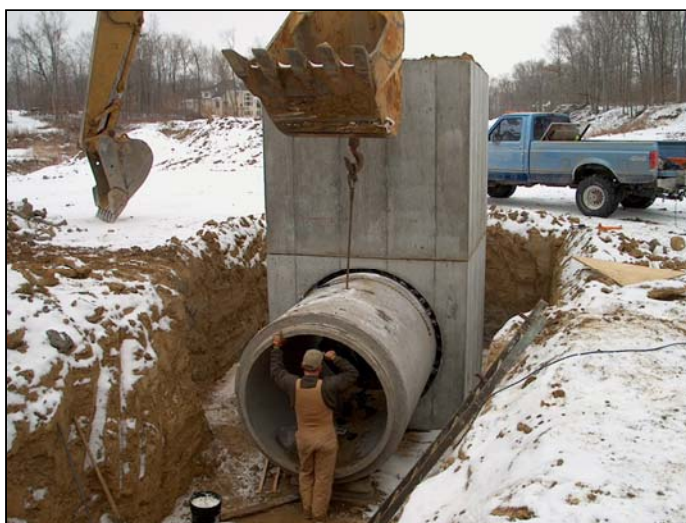
Figure 3-7 Installation of a riser pipe during winter weather.

understand an observed condition. [Figure 3-7](#) shows a dam's riser structure being installed during cold weather conditions. Troubleshooting potential future seepage problems along the discharge pipe may be aided if such photographs are available in the dam owner's project files.

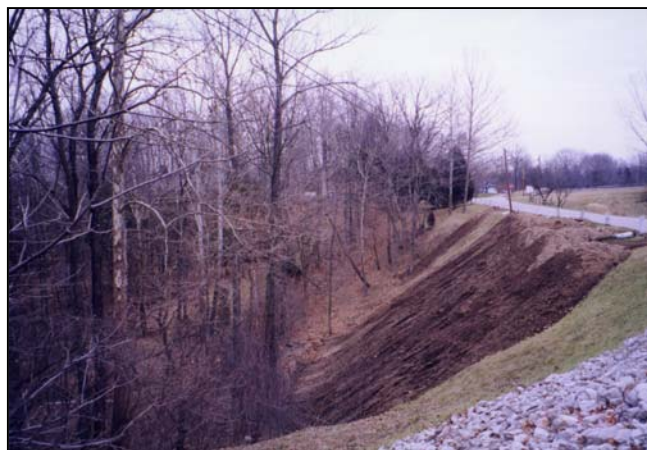
Figure 3-8 Loose fill inappropriately added to embankment slope.

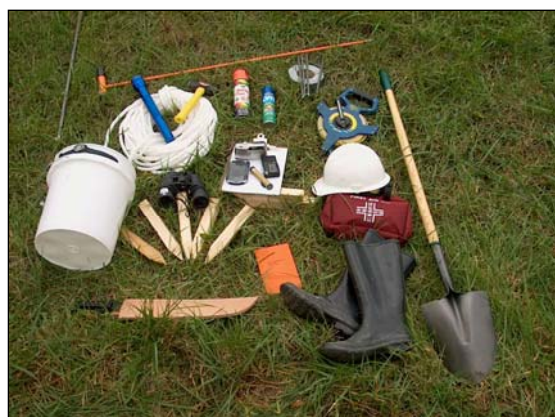
Figure 3-9 A typical inspection field kit.

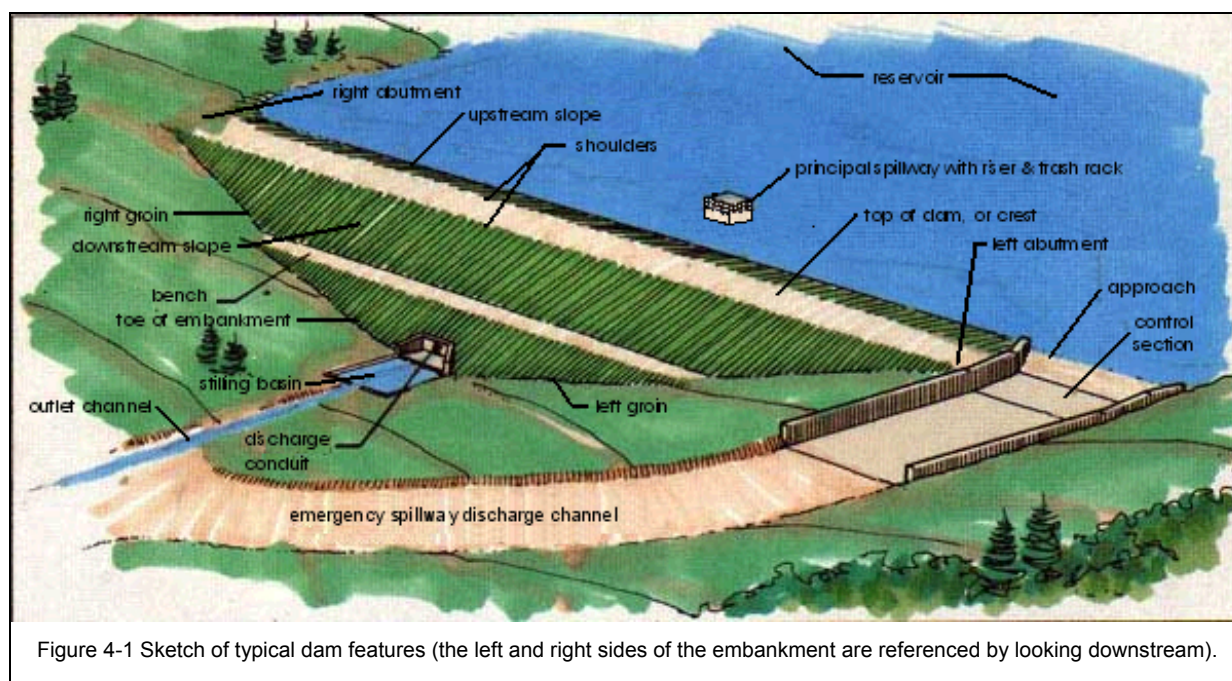
Figure 4-1 shows typical features that require inspection and are common on embankment dams. Dam features and descriptions should be referenced “looking downstream.” For example, with the inspector standing on the embankment crest and looking downstream, the abutment on his/her right is the right abutment; the abutment on his/her left is the left abutment. Concrete dams may have similar features except they do not have an earthen embankment. Other features that are common at dams but are not shown include rock toe drains with piping, cutoff trenches, and riprap groin areas.

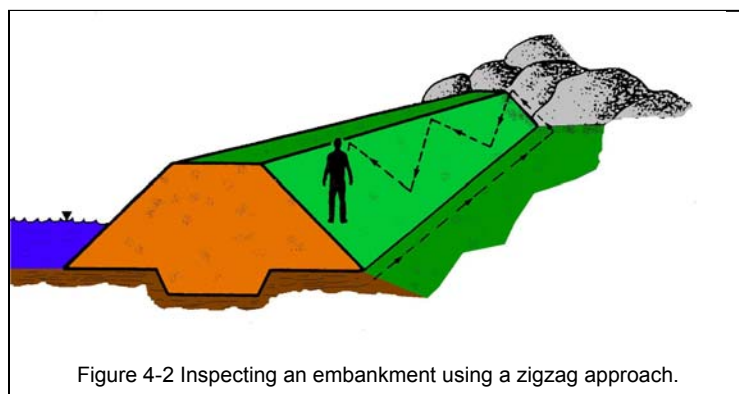
Figure 4-2 Inspecting an embankment using a zigzag approach.

Zigzag (See Figure 4-2)

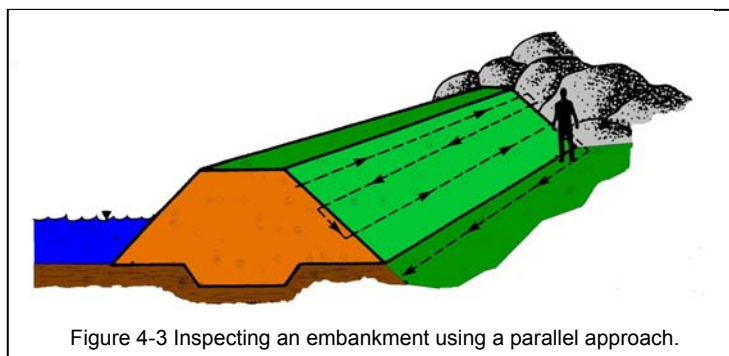
A second approach is to make a series of passes parallel to the crest of the dam, moving down the slope. It is preferable to use parallel passes on larger slopes or on slopes that are very steep, since this method is less arduous.

Figure 4-3 Inspecting an embankment using a parallel approach.

Parallel (See Figure 4-3)

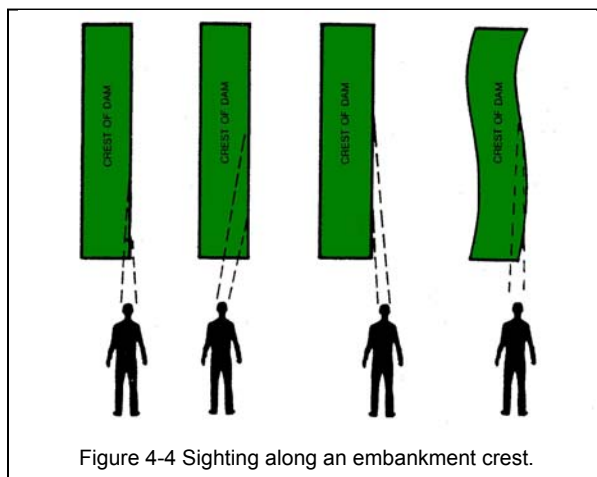
of Figure 4-4 show sighting along a straight embankment, while the sketches on the right side of the figure shows sighting of a bowed embankment.

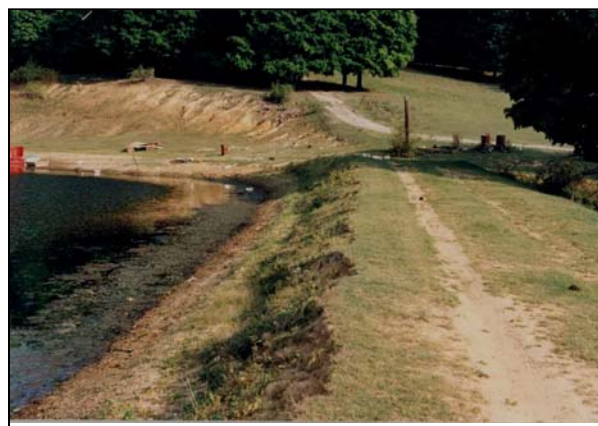
Figure 4-5 Crest problems may be easily seen by sighting along a straight line on the crest.

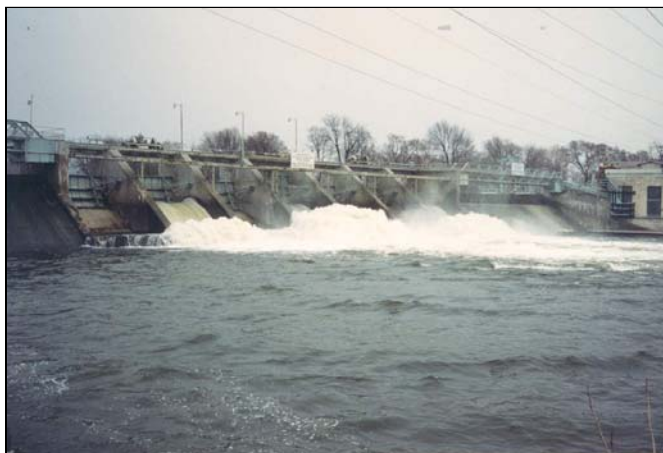
Figure 4-8 Dam with significant concrete spillway structures.

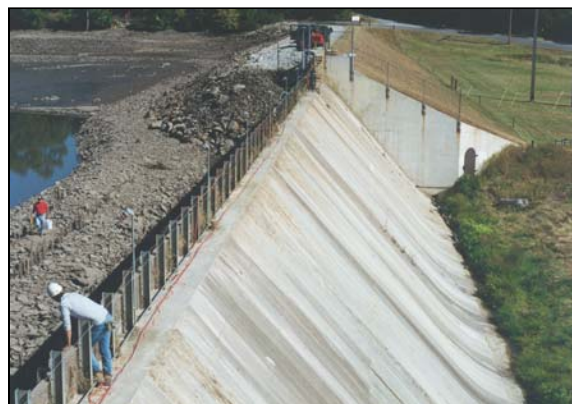
Figure 4-9 Dam requiring extensive concrete inspection.

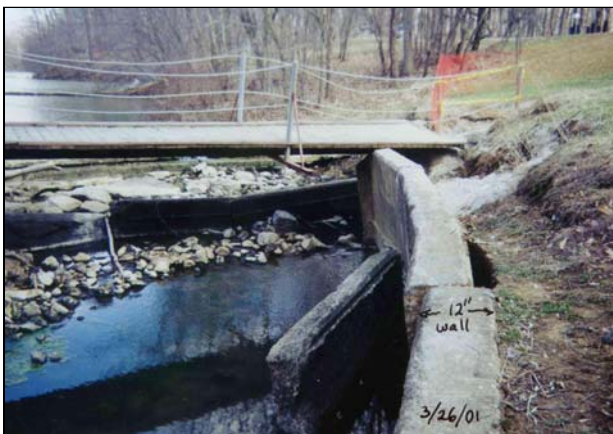
Figure 4-11 A picture is invaluable documentation.

It is recommended that the inspector use a 35mm camera or a digital camera (preferable) to take photographs during an inspection. These cameras typically have provisions for zooming in to magnify the features being observed. If a 35mm or digital camera is not available, an instant camera may be substituted. Using an instant camera may be helpful since the inspector can see the quality of the photographs while onsite. Also, instant photographs can be used for any immediate consultations that may be necessary back at your office. Color photographs are preferred to black-and-white prints because the color of certain deficiencies is important inspection information (e.g., changes in the color of concrete or vegetation). It is often hard to describe in words what can be captured in a photograph (see Figure 4-11).

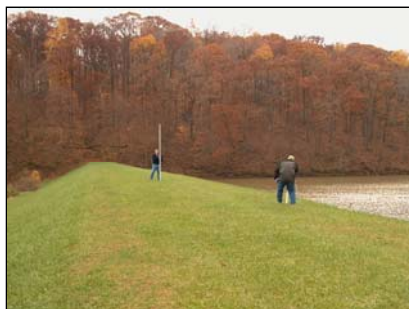
Figure 4-12 Picture with shutter speed controlled by the treeline.

One other factor that should be taken into consideration when choosing camera position is the quality of available light. Poor lighting obviously will result in poor pictures. Choose the camera position so as to make the most of angle and lighting. Also, watch out for shadows that will block out important details or sun in the camera lens. Figure 4-12 shows an example of picture quality when an automatic digital camera shutter speed is controlled by including the trees in the background rather than the sky; the result is a brighter picture. Figure 4-13 shows a photograph of the same scene at about the same time, but with more of the sky included in the background; the result is a shutter speed adjustment based on the sky. A darker picture is the result.

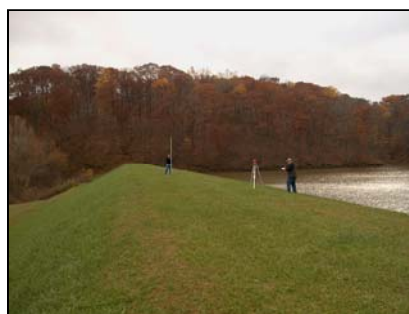
Figure 4-13 Picture with shutter speed controlled by the skyline.

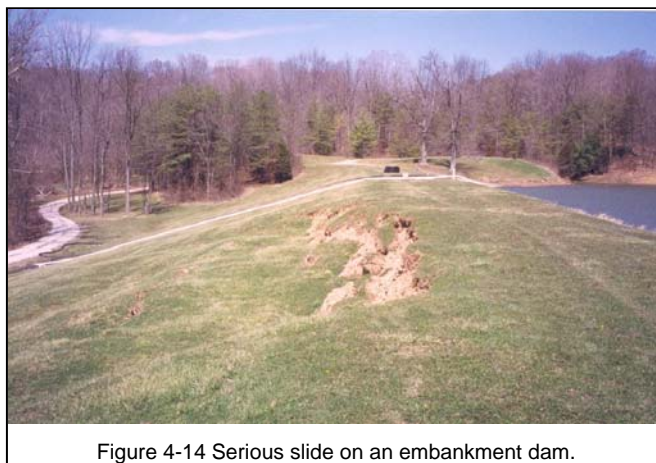
Figure 4-14 Serious slide on an embankment dam.

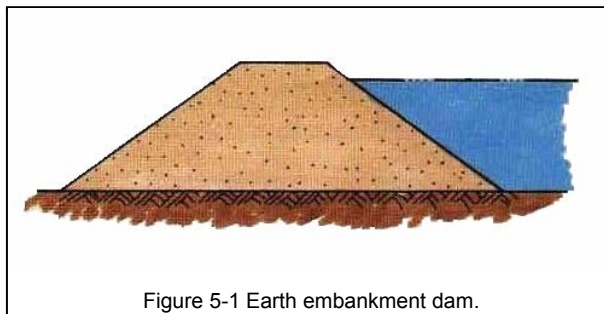
Figure 5-1 Earth embankment dam.

Earth Dam (or earthfill dam) - An embankment dam in which more than 50% of the total volume is formed of compacted inorganic soil material obtained from a borrow area (see Figure 5-1).

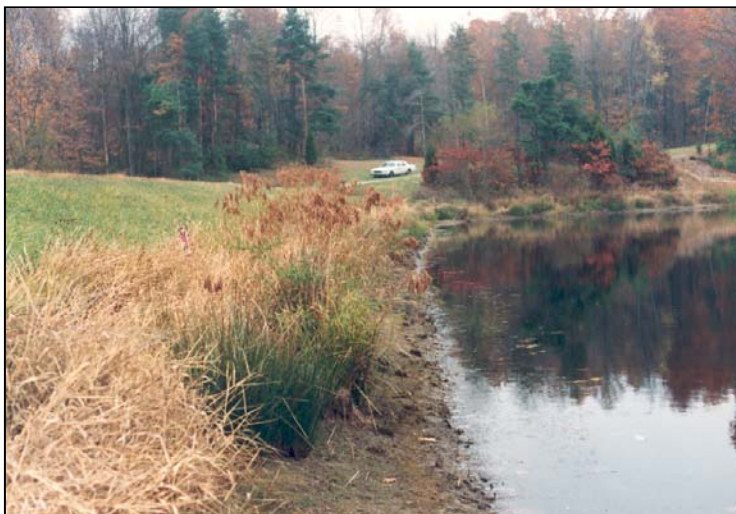
Figure 5-2 Embankment slope inspection can be hindered with excessive vegetation.

The upstream slope needs a thorough visual inspection, since the slope protection, vegetation, debris, and reservoir water can hide problems. Anytime the reservoir is emptied, the slope should be thoroughly inspected for settlement areas, animal burrows, sinkholes, or slides. Also, the reservoir basin (bottom of the reservoir) should be inspected for sink holes or settlement anytime the reservoir is emptied.

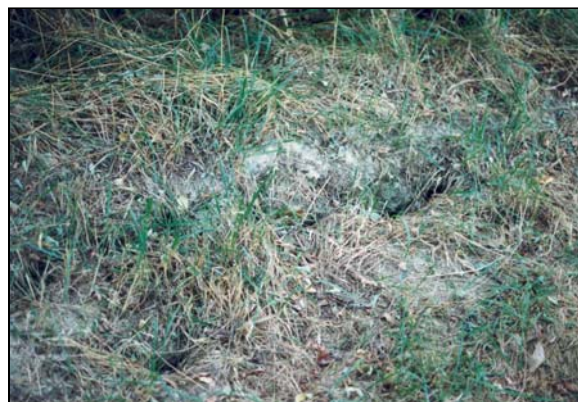
Figure 5-3 Longitudinal cracks on embankment slope.

Longitudinal cracking may indicate localized instability, differential settlement, foundation settlement, and movement between adjacent sections of the embankment. In recently built structures, longitudinal cracks may indicate inadequate compaction of the embankment during construction. This form of cracking can occur anywhere on an embankment. Longitudinal cracking is characterized by a single crack or a close, parallel system of cracks along the crest or slope in a direction more or less parallel to the length of the dam.

These cracks, which are continuous over their length and are usually greater than 1 foot deep, can be differentiated from drying cracks which are usually intermittent, erratic in pattern, shallow, very narrow, and numerous. Longitudinal cracking usually signals the early stages of a slide or slough, and may precede vertical displacement as the dam attempts to move to a position of greater stability. In this case, the crack usually develops into a scarp which forms during movement of unstable slopes. Vertical displacements on the crest are usually accompanied by displacements or bulging on the upstream or downstream faces of the dam.

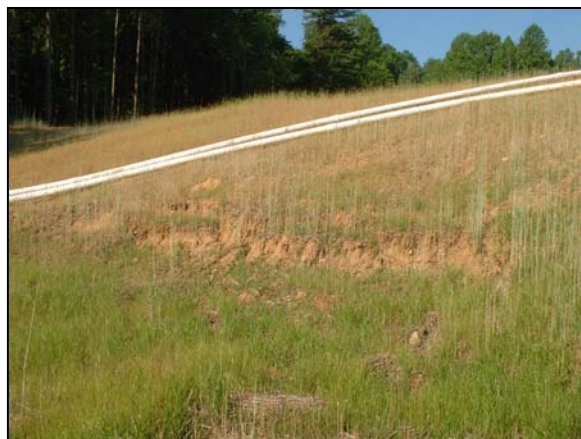
Figure 5-11 Shallow slide at toe of embankment resulting from excessive seepage and poor compaction.

slides may be difficult to spot if a scarp has not developed. Their appearance may be subtle, since there may be very little settlement or bulging out from the normal slope. A good familiarity with how the slope looked at the end of construction will help identify any new slides. Figures 5-11 and 5-14 illustrate slides on the downstream slope, with vertical and horizontal movement and the formation of a scarp.

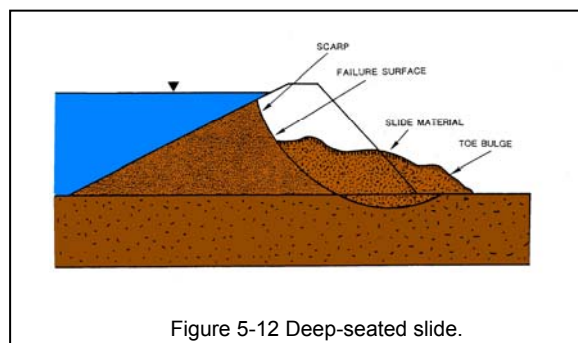
Figure 5-12 Deep-seated slide.

Deep-seated slides are serious threats to the safety of the dam. Deep-seated slides may be recognized by the presence of a well-defined scarp or bulging on the slope or at the toe. Arc-shaped cracks on the slope are usually indications that a slide is beginning. This type of crack may develop into a large scarp at the top of the slide.

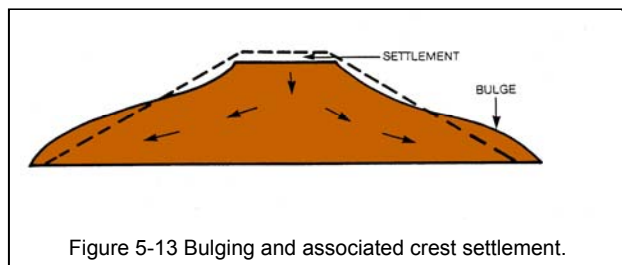
Figure 5-13 Bulging and associated crest settlement.

Bulging is usually associated with the lateral spreading of the dam or with slides. Bulging as a result of lateral deformation is accompanied by settlement of the crest and a potential loss in dam freeboard. The bulging is most evident at the toe of the dam. If the inspector suspects a loss of freeboard, a survey of the crest should be performed to

verify if there has been a loss of freeboard. The area above a bulge should be examined carefully in order to identify other indicators of instability such as cracks and scarps. Not all bulges indicate a stability problem. When the dam was constructed, it may not have been uniformly graded by the dozer or grader operator, so there may be bulges in the embankment that were formed during construction. The inspector should determine the cause of the bulging and recommend a course of action. Bulging associated with slides is a more serious problem. If bulging associated with cracks or scarps is observed, a qualified dam safety professional should be contacted immediately.

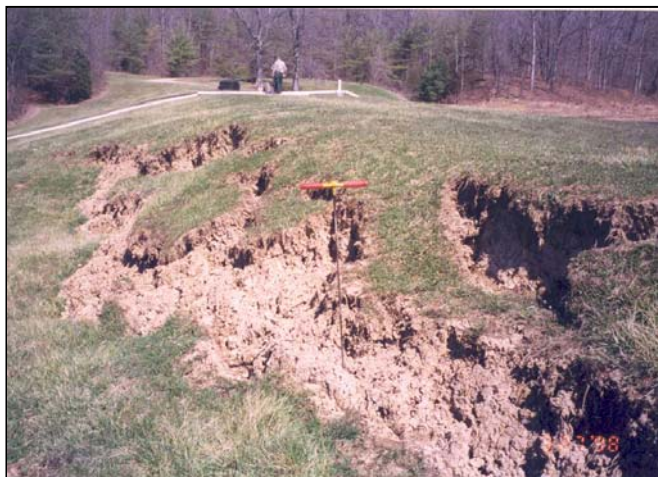
Figure 5-14 Large slide on embankment with prominent scarp.

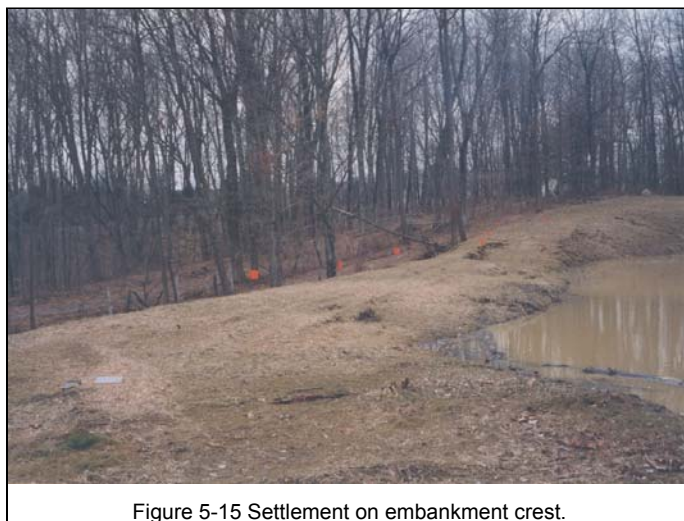
Figure 5-15 Settlement on embankment crest.

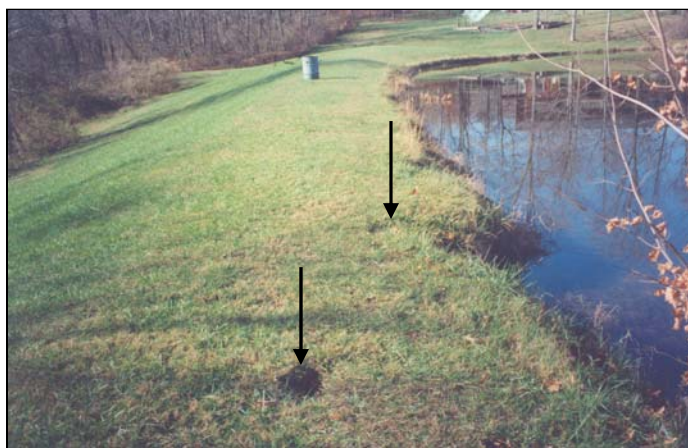
Figure 5-16 Sinkholes developing from muskrat burrows.

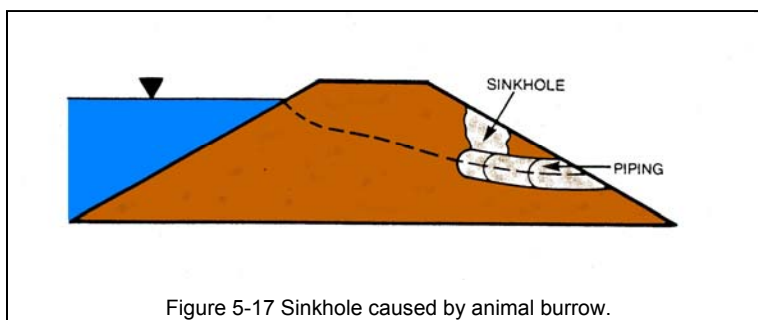
Figure 5-17 Sinkhole caused by animal burrow.

Sinkholes are a serious type of depression that can result in hazardous embankment safety conditions. Sinkholes are formed when the removal of subsurface embankment or foundation material has caused overlying material to collapse into the resulting void. The

presence of a sinkhole may indicate that material has been transported out of the dam or foundation through the process of piping. In addition, animal burrows, and flowing water under pipes, walls, and slabs can contribute to the formation of sinkholes. The decomposition of embedded wood or other vegetative matter in the embankment also can cause sinkholes. If the embankment depressions or settlement progresses to a level below the normal pool elevation, the reservoir may overtop the embankment, resulting in breaching or total embankment failure. Settlement also reduces the storage capacity and freeboard of the dam which could result in overtopping, breaching, or failure during storm events.

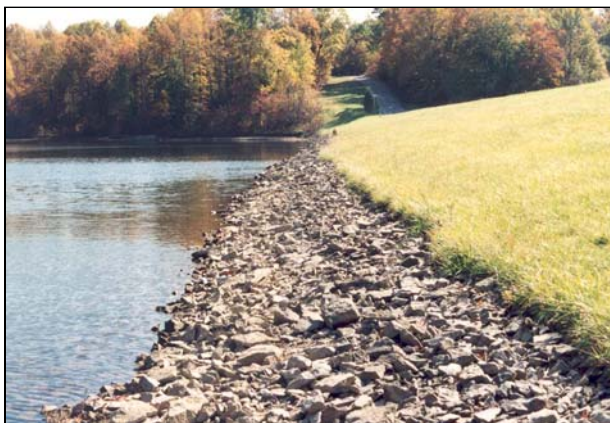
Figure 5-18 Riprap protection on the embankment slope at the shoreline, with grass on the rest of the slope.

The two primary types of slope protection used on embankment dams include vegetative cover (grass) and riprap (rock). Grass cover is usually used on most embankment surfaces, while riprap is commonly used on the shoreline of the upstream slope. Soil cement, concrete, asphalt, articulated concrete blocks, and other types of slope protection also may be used. The type of slope protection selected depends upon economics, how the dam is used, and the prevailing conditions found at the site. A good growth of grass on an embankment provides excellent protection against erosion caused by rainfall and runoff. Deep-rooted grass that can tolerate repeated wetting and drying cycles should be used on embankments. Figure 5-19 shows an embankment experiencing shoreline erosion as a result of inadequate slope protection. The shoreline

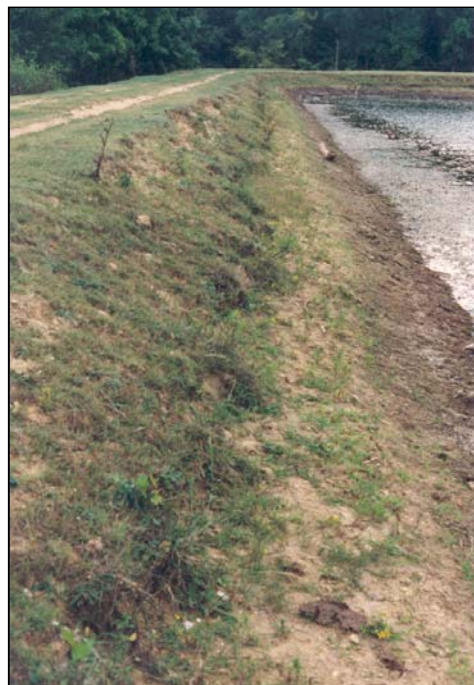
Figure 5-19 Inadequate slope protection resulting in shoreline erosion.

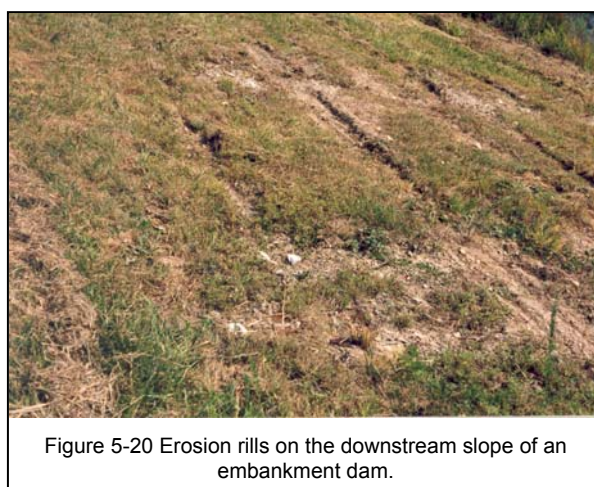
Figure 5-20 Erosion rills on the downstream slope of an embankment dam.

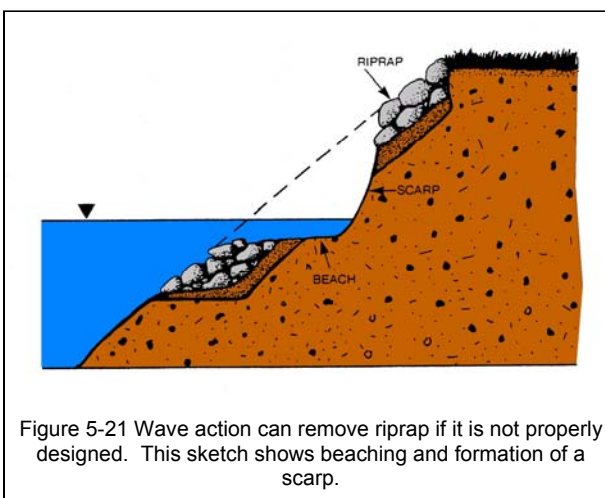
Beaching is the removal of a portion or portions of the upstream slope of the embankment by wave action. Figures 5-21 and 5-22 show the effects of erosion and beaching on the upstream slope of a dam. When beaching occurs, embankment material is deposited farther down the slope. In this extreme form of erosion, the slope protection (i.e., riprap or vegetative cover) and underlying material are removed. A relatively flat beach area with a steep back slope, or scarp, is formed. Scarps should be monitored regularly for additional deterioration and repaired if conditions get worse.

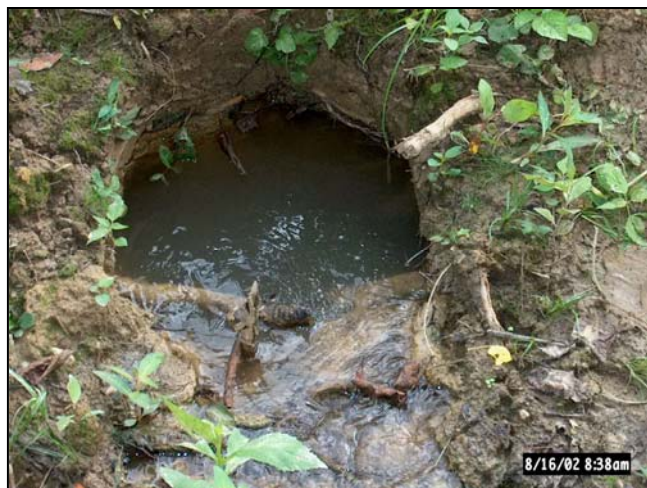
Figure 5-40 Piping with clear discharge may indicate that no additional soil is being removed from the foundation.

It can be difficult to determine the source of seepage, since the exit may be the only visible condition observed. The seepage pipe shown in Figure 5-40 was observed a few feet below the toe of an earth embankment, and it was not clear whether the water was flowing through the embankment or under it.

No sand or other soil was being carried by the seeping water, and the reservoir level was slowly getting lower, so the pipe was probably already formed. Seepage may originate in the bottom of the reservoir, upstream of the embankment, and travel through porous soil strata in the foundation of the dam.

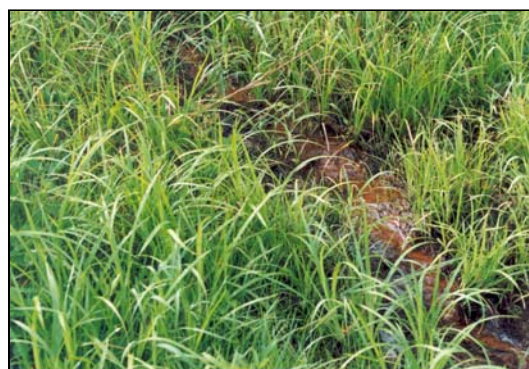
Figure 5-41 This seepage has produced iron oxide stains.

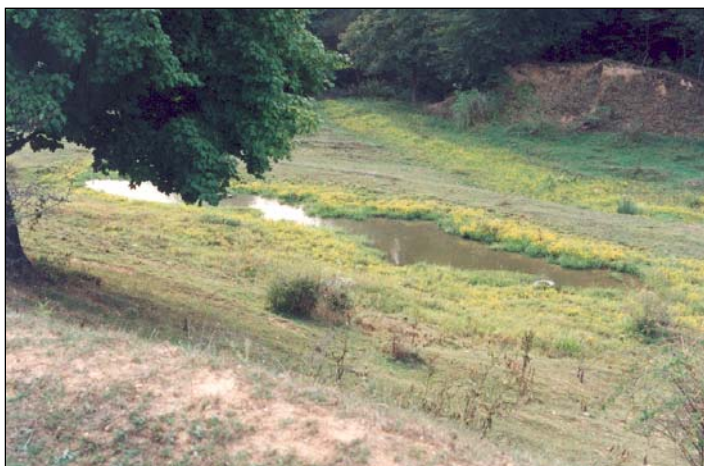
Figure 5-42 Excessive seepage near embankment toe.

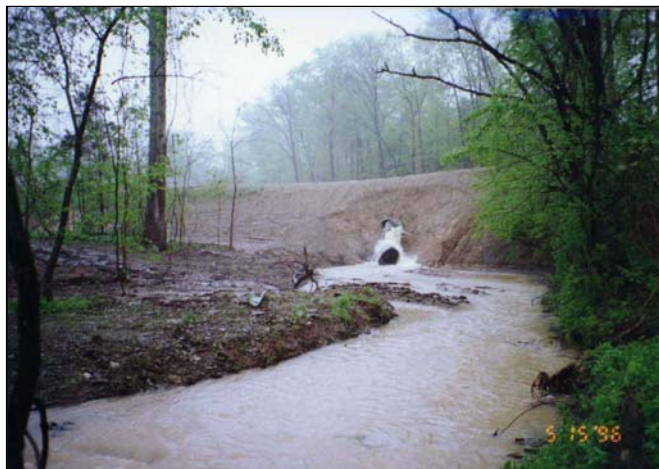
Figure 5-43 Seepage along the spillway in this dam has resulted in piping and a serious leak.

under pressure into the embankment. Rapid erosion and an eventual breaching of the dam can result from seepage around conduits. [Figure 5-43](#) shows serious piping along a spillway conduit. This type of seepage is excessive and will continue to erode the soils around the conduit.

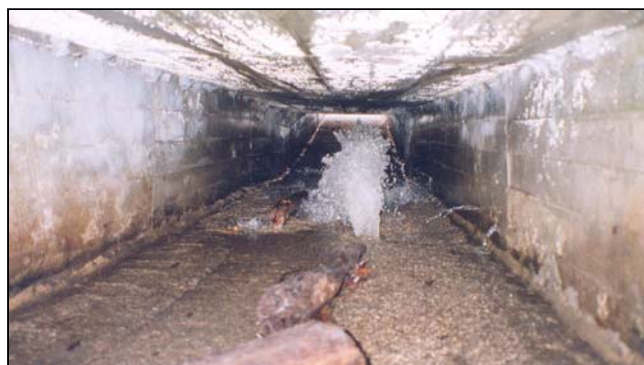
Figure 5-44 Seepage under this spillway conduit has caused piping, allowing a significant leak through conduit deficiencies.

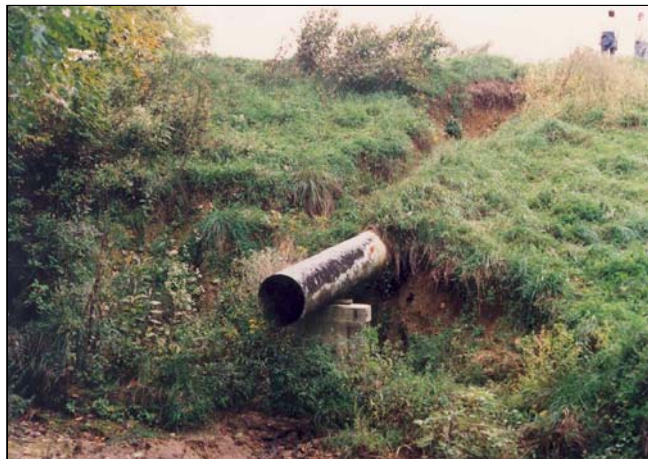
Figure 5-45 Seepage along this spillway conduit has caused piping, sinkholes, and eventual erosion of all the soil over the conduit.

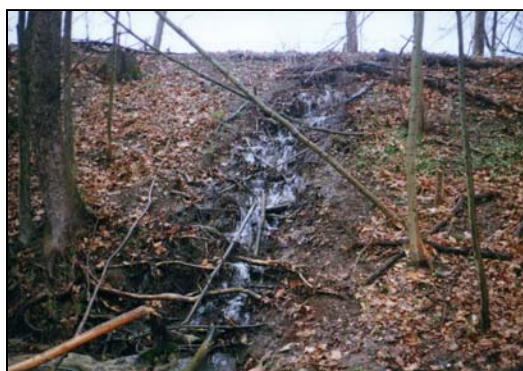
Figure 5-46 Seepage caused by tree roots through the embankment.

Seepage can be caused by deep-rooted vegetation on embankments, such as trees. Tree roots can penetrate the embankment and create passageways for water. Seepage along root

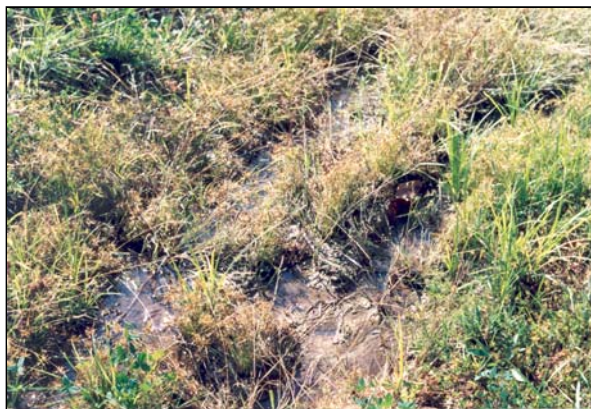
Figure 5-47 Typical photograph of seepage accumulating in low areas.

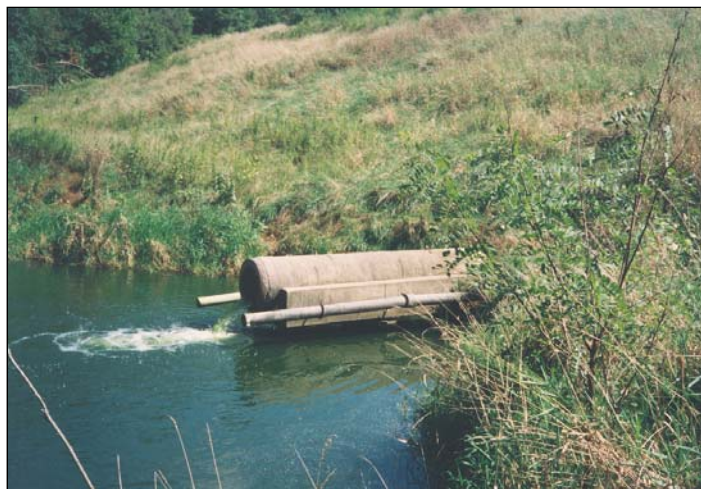
Figure 5-48 Collector pipes (beside spillway conduit) can be used to help monitor seepage through the embankment.

Many **toe drains** have collector pipes that discharge the embankment and foundation seepage at accessible locations. Before conducting a visual inspection of an embankment dam that has toe drains, the inspector should review the site plan to determine the location of the toe drains and outfalls. Previous data on both the reservoir level and flow rate from the drain(s) should be reviewed. Data on drain flow must be looked at in conjunction with reservoir-level data. Correlating the reservoir level with the drain flow can help to determine if there is a problem. If a drain flow is observed that is atypical for the given reservoir level, more investigation is essential.

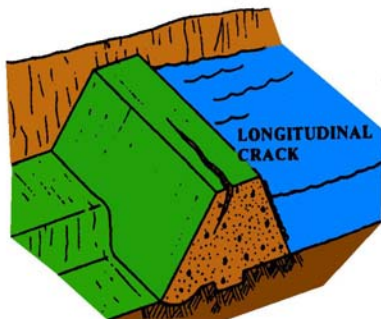
PROBLEMS**LONGITUDINAL CRACKING**

1. Uneven settlement between adjacent sections or zones within the embankment.
2. Foundation failure causing loss of support to embankment.

1. Creates local area of low strength within embankment. Could be the point of initiation of future structural movement, deformation, or failure.
2. Provides entrance point for surface run-off into embankment, allowing saturation of adjacent embankment area and possible lubrication which could lead to localized failure.

1. Inspect crack and carefully record location, length, depth, width, alignment, and other pertinent physical features. Immediately stake out limits of cracking. Monitor frequently.
2. Engineer should determine cause of cracking and supervise steps necessary to reduce danger of dam and correct condition.
3. Effectively seal the cracks at the crest's surface to prevent infiltration by surface water.
4. Continue to routinely monitor crest for evidence of further cracking.

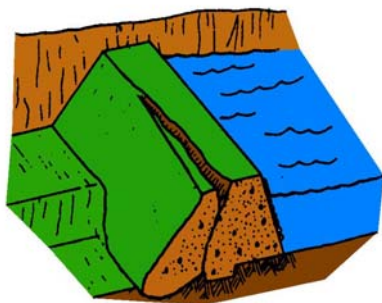
**VERTICAL DISPLACEMENT**

1. Vertical movement between adjacent sections of the embankment.
2. Structural deformation or failure caused by structural stress or instability, or by failure of the foundation.

1. Provides local area of low strength within embankment which could cause future movement.
2. Leads to structural instability or failure.
3. Provides entrance point for surface water that could further lubricate failure plane.
4. Reduces available embankment cross section.

1. Carefully inspect displacement and record its location, vertical and horizontal displacement, length, and other physical features. Immediately stake out limits of cracking.
2. Engineer should determine cause of displacement and supervise all steps necessary to reduce danger to dam and correct condition.
3. Excavate area to the bottom of the displacement. Backfill excavation, using competent material and correct construction techniques, under supervision of engineer.
4. Continue to monitor areas routinely for evidence of future cracking or movement.

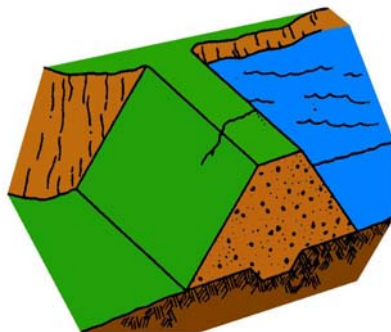
**TRANSVERSE CRACKING**

1. Uneven movement between adjacent segments of the embankment.
2. Deformation caused by structural stress or instability.

1. Can provide a path for seepage through the embankment cross section.
2. Provides local area of low strength within embankment. Future structural movement, deformation, or failure could begin at this point.
3. Provides entrance point for surface run-off to enter embankment.

1. Inspect crack and carefully record crack location, length, depth, width, and other pertinent physical features. Stake out limits of cracking.
2. Engineer should determine cause of cracking and supervise all steps necessary to reduce danger to dam and correct condition.
3. Excavate crest along crack to a point below the bottom of the crack. Then backfill excavation using competent material and correct construction techniques. This will seal the crack against seepage and surface run-off. This should be supervised by engineer.
4. Continue to monitor crest routinely for evidence of future cracking.

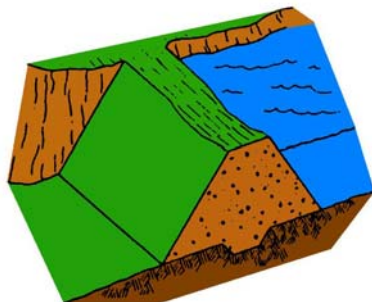
PROBLEMS**CREST ALIGNMENT**

1. Movement between adjacent portions of the structure.
2. Uneven deflection of dam under loading by reservoir.
3. Structural deformation or failure near area of misalignment.

1. Area of misalignment is usually accompanied by low area in crest which reduces free board.
2. Can produce local areas of low embankment strength which may lead to failure.

1. Establish monuments across crest to determine exact amount, location, and extent of misalignment.
2. Engineer should determine cause of misalignment and supervise all steps necessary to reduce threat to dam and correct condition.
3. Monitor crest monuments on a schedule basis following remedial action to detect possible future movement.

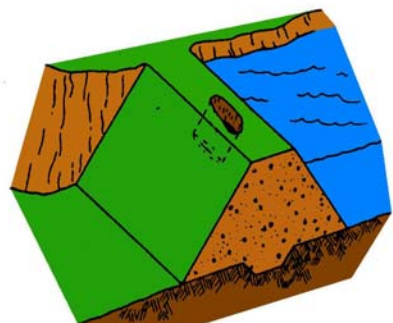
SINKHOLE IN CREST

1. Rodent activity.
2. Hole in outlet conduit is causing erosion of embankment material.
3. Internal erosion or piping of embankment material by seepage.
4. Breakdown of dispersive clays within embankment by seepage waters.

1. Void within dam could cause localized caving, sloughing, instability, or reduced embankment cross section.
2. Entrance point for surface water.

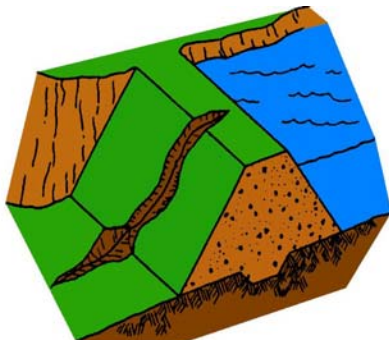
GULLY ON CREST

1. Poor grading and improper drainage of crest. Improper drainage causes surface run-off to collect and drain off crest at low point in upstream or downstream shoulder.
2. Inadequate spillway capacity which has caused dam to overtop.

1. Restore freeboard to dam by adding fill material in low area, using proper construction techniques.
2. Re-grade crest to provide proper drainage of surface run-off.
3. If gully was caused by over-topping, provide adequate spillway which meets current design standards. This should be done by engineer.
4. Re-establish protective cover.

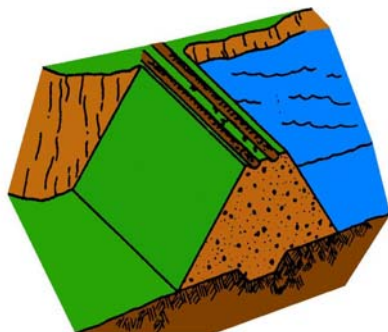
RUTS ALONG CREST

Heavy vehicular traffic without adequate or proper maintenance or proper crest surfacing.

1. Drain standing water from ruts.
2. Re-grade and re-compact crest to restore integrity and provide proper drainage toward upstream slope.
3. Provide gravel or road base material to accommodate traffic.
4. Perform periodic maintenance and re-grading to prevent reformation of ruts.

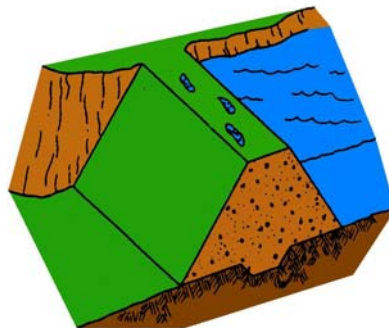
PUDDLING ON CREST; POOR DRAINAGE

1. Poor grading and improper drainage of crest.
2. Localized consolidation or settlement on crest allows puddles to develop.

1. Drain standing water from puddles.
2. Re-grade and re-compact crest to restore integrity and provide proper drainage toward upstream slope.
3. Provide gravel or road base material to accommodate traffic.
4. Perform periodic maintenance and re-grading to prevent reformation of ruts.

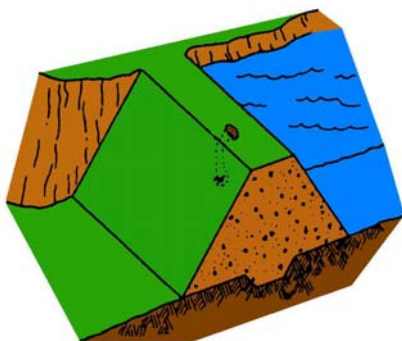
RODENT ACTIVITY ON CREST

Burrowing animals.

1. Completely backfill the hole with competent, well compacted material.
2. Initiate a rodent control program to prevent the propagation of the burrowing animal population and to prevent future damage to the dam.

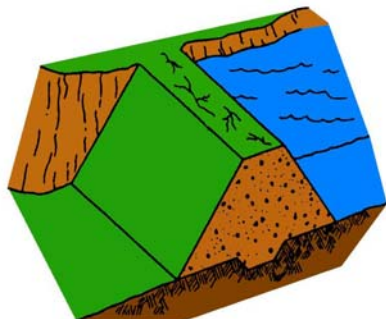
PROBLEMS**DRYING CRACKS**

Material on the crest of dam expands and contracts with alternate wetting and drying of weather cycles. Drying cracks are usually short, shallow, narrow, and numerous.

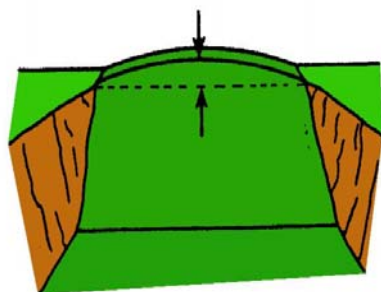
CREST CAMBER

Results from construction. Proportionally more fill is placed on crest in higher segments of the embankment during construction to compensate for anticipated settlement within the dam and foundation.

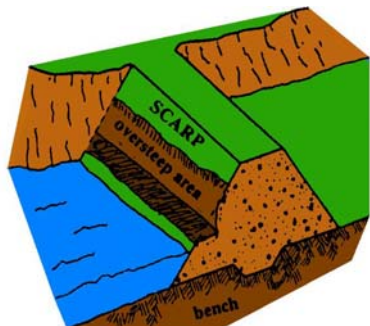
PROBLEMS**CAUSES & HARM DONE****ACTION REQUIRED****SCARPS, BENCHES, OVERSTEEP AREAS**

Wave action, local settlement, or ice action cause soil and rock to erode and slide to the lower part of the slope forming a bench.

Determine exact cause of scarps. Do necessary earthwork, restore embankment to original slope, provide adequate protection (bedding and riprap).

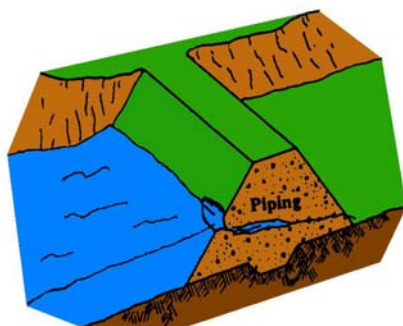
SINKHOLE

The piping of embankment material or foundation material causes a sink hole. The cave-in of an eroded cavern can result in a sink hole. A small hole in the wall of an outlet pipe can develop a sink hole.

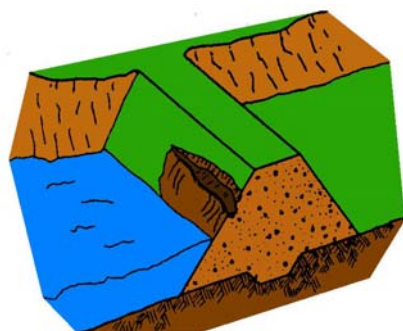
SLIDE, SLUMP, OR SLIP

Earth or rocks move down the slope along a slippage surface because they were on too steep a slope, or the foundation moves. Also, look for slides in reservoir basin.
